Pre-Demolition Hazardous Materials Survey Report

Edgefield Buildings B and F 2345 NE 244th Avenue Wood Village, OR 97060

Reynolds School District No. 7

April 2021 Project No.: 23514.174 Phase No.: 0001

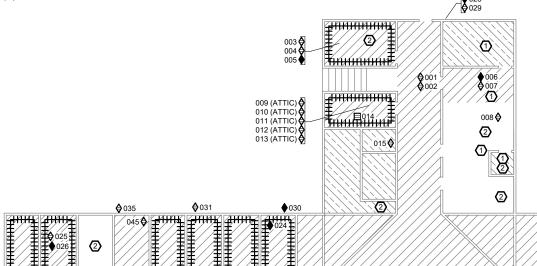
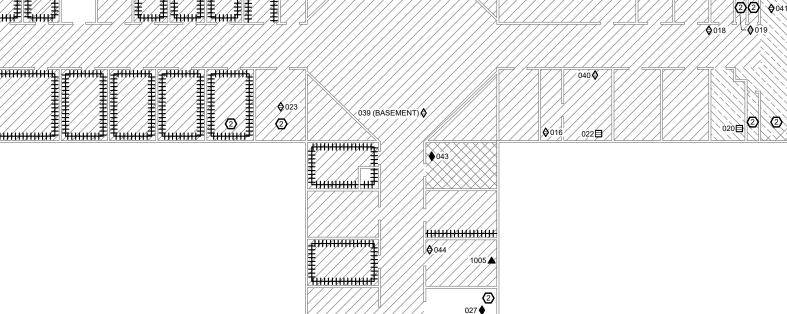
FIRST FLOOR PLAN - BUILDING "F"

DRAWING REFERENCE	FIELD CODE	LAB RESULT	MATERIAL SAMPLED
♦024	23514.174-0024	(-/<1%/-)	MASTIC
♦ 025	23514.174-0025	(-/-/-)	SHEET FLOOR COVERING
♦026	23514.174-0026	(+/-)	VINYL FLOOR TILE/MASTIC
♦027	23514.174-0027	(+)	BUILT-UP ROOFING
♦028	23514.174-0028	(<1%)	CAULK
Q 029	23514.174-0029	(-/-)	BRICK & MORTAR
♦030	23514.174-0030	(+)	CAULK
Q 031	23514.174-0031	(-)	CONCRETE COATING
Q 035	23514.174-0035	(-)	WINDOW GLAZING COMPOUND
Q 039	23514.174-0039	(-)	CONCRETE ROOFING
Q 040	23514.174-0040	(-/-)	WALL AND CEILING PLASTER
Q 041	23514.174-0041	(-/-/-)	WALL AND CEILING PLASTER
Q 042	23514.174-0042	(-/-/-)	GYPSUM WALLBOARD/
			JOINT COMPOUND
♦ 043	23514.174-0043	(<1%/-)	WALL AND CEILING PLASTER
Q 044	23514.174-0044	(-/-/-)	WALL AND CEILING PLASTER
Q 045	23514.174-0045	(-/-)	WALL AND CEILING PLASTER

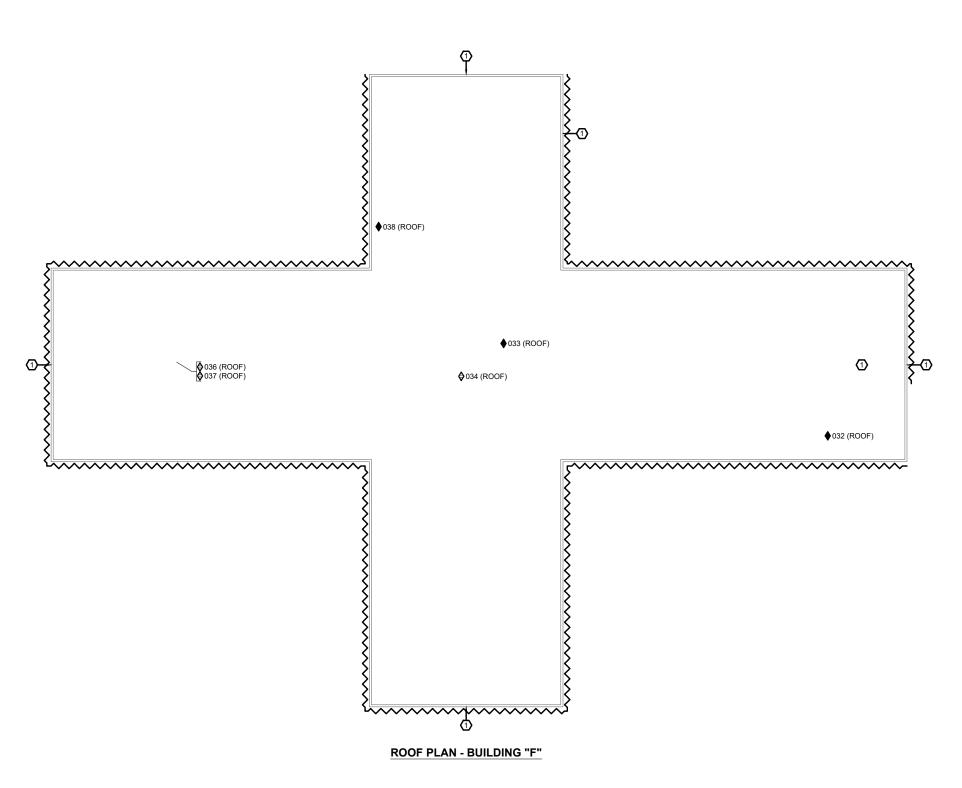
HS₂ неет **2** оғ **3**

DRAWING REFERENCE	FIELD CODE	LAB RESULT	MATERIAL SAMPLED
032 033 034	23514.174-0032 23514.174-0033 23514.174-0034		BUILT-UP ROOFING BUILT-UP ROOFING
♦ 036 ♦ 037	23514.174-0036 23514.174-0037	(-/-/-/-/-/-) (-)	BUILT-UP ROOFING MASTIC
038	23514.174-0037	(+)	MASTIC
