BR|IC

BY BRIC ARCHITECTURE, INC. MARCH 2021

Reynolds School District's educational facilities range from 2 to 66 years in age. All facilities have benefited from a high level of care and maintenance. However, many of the facilities exhibit deferred maintenance issues, systems and/or finishes at the end of their useful life, accessibility issues and/or building code deficiencies. Deferred maintenance refers to those maintenance items or building repairs which may not have been performed at an optimum time due to budget or staffing constraints. The older facilities in this District require various upgrades in order to meet educational and operational needs, ensuring the future longevity of each school. Prevailing themes from the assessments included the following:

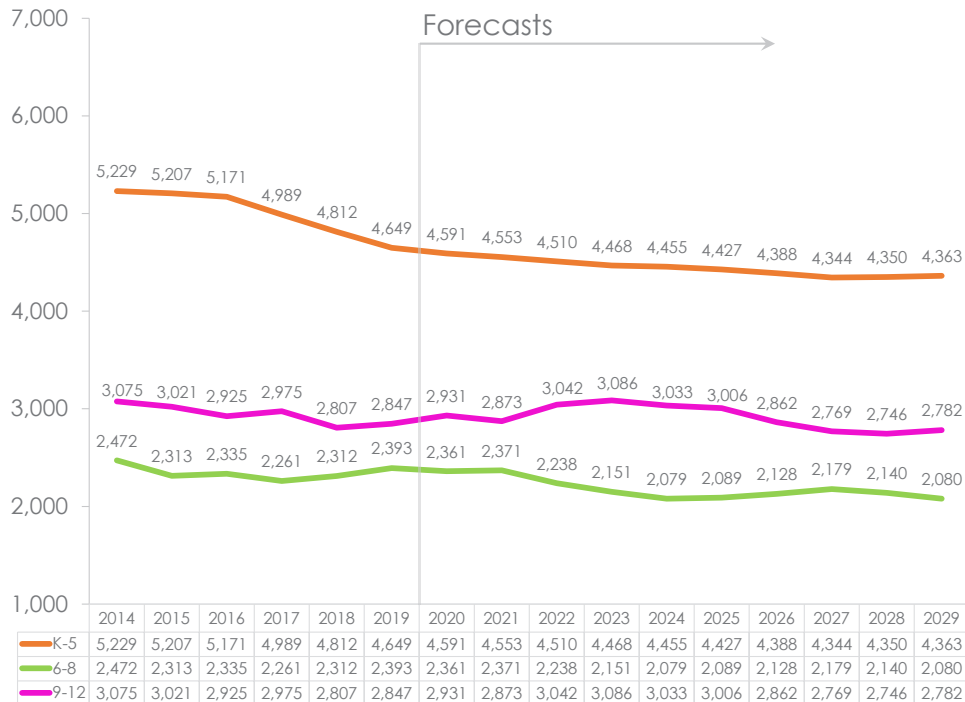
Figure 10: Building Attendance Enrollment Forecasts (Headcount) by Grade Group — Medium Growth Series (Preferred)

October 1, 2019, building attendance enrollment forecasts (headcount) through 2029-30 by grade group, medium-growth series. Includes all schools and students living both within and outside the District, except for preschool students and students attending Multnomah (formerly Multisensory) Learning Academy, Reynolds Arthur Academy, and Rockwood Preparatory Academy.

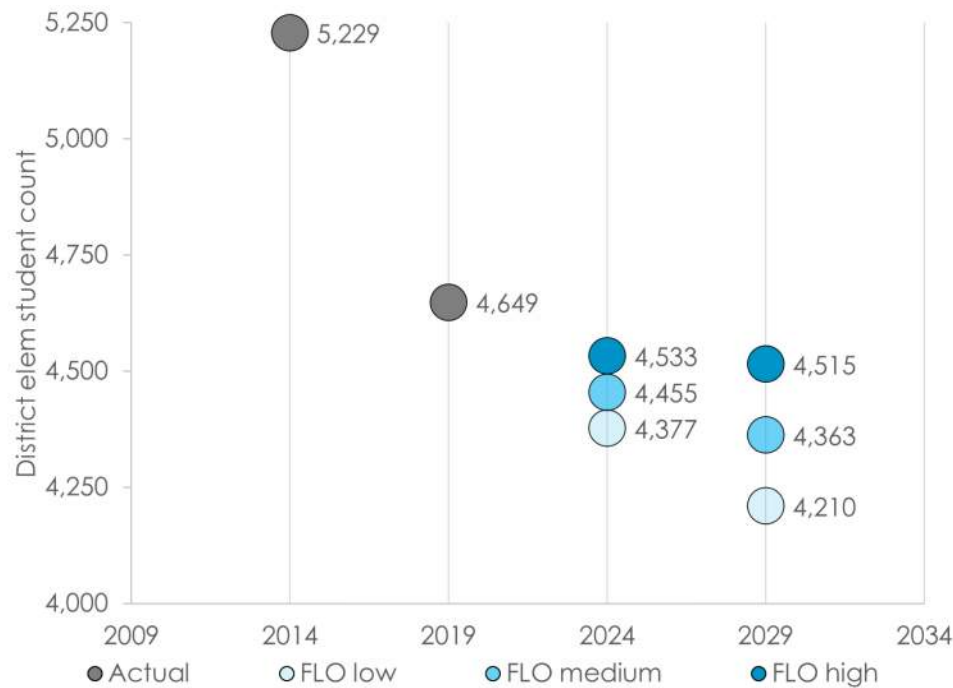
Figure 11: Elementary School Building Attendance Enrollment Forecasts (Headcount) — Low-, Medium- (Preferred), and High-Growth Series

Elementary school October 1, 2019, building attendance enrollment forecasts (headcount) for 2024 and 2029 — low-, medium-, and high-growth series. Includes all schools and students living both within and outside the District, except for preschool students and students attending Multnomah (formerly Multisensory) Learning Academy, Reynolds Arthur Academy, and Rockwood Preparatory Academy.

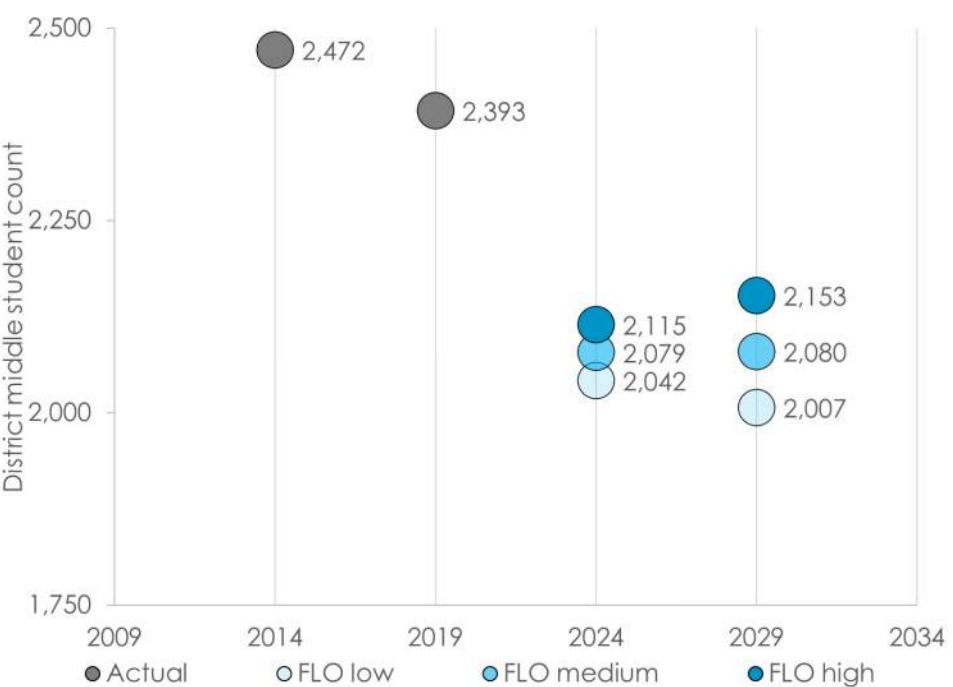
Middle school October 1, 2019, building attendance enrollment forecasts (headcount) for 2024 and 2029 — low-, medium-, and high-growth series. Includes all schools and students living both within and outside the District, except for preschool students and students attending Multnomah (formerly Multisensory) Learning Academy, Reynolds Arthur Academy, and Rockwood Preparatory Academy.

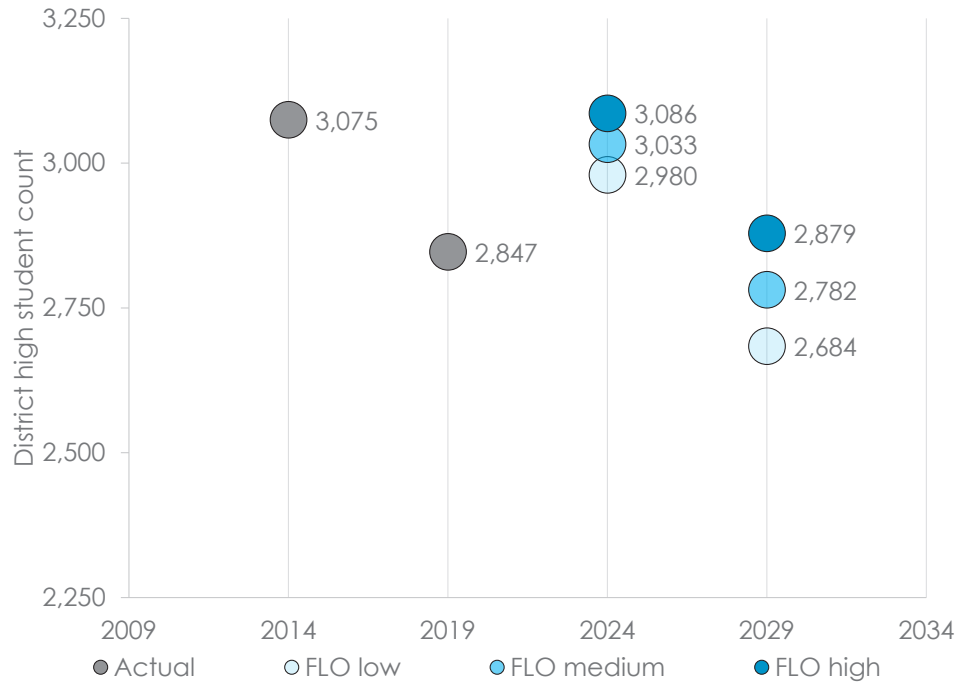
High school October 1, 2019, building attendance enrollment forecasts (headcount) for 2024 and 2029 — low-, medium-, and high-growth series. Includes all schools and students living both within and outside the District, except for preschool students and students attending Multnomah (formerly Multisensory) Learning Academy, Reynolds Arthur Academy, and Rockwood Preparatory Academy.
