REYNOLDS SCHOOL DISTRICT

Long Range Facility Planning Report

BY BRIC ARCHITECTURE, INC. MARCH 2021

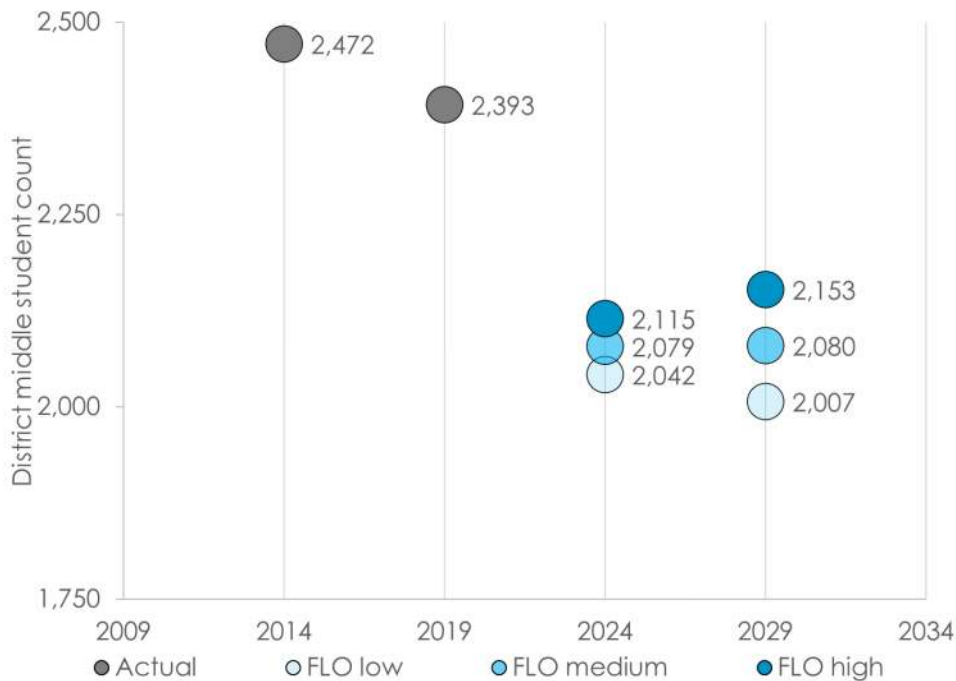
Figure 12: Middle School Building Attendance Enrollment Forecasts (Headcount) — Low-, Medium- (Preferred), and High-Growth Series

Middle school October 1, 2019, building attendance enrollment forecasts (headcount) for 2024 and 2029 — low-, medium-, and high-growth series. Includes all schools and students living both within and outside the District, except for preschool students and students attending Multnomah (formerly Multisensory) Learning Academy, Reynolds Arthur Academy, and Rockwood Preparatory Academy.
