ROOF PLAN - BUILDING "F"

HAZARDOUS MATERIAL ABATEMENT PLAN
EDGEFIELD SITE
2345 NE 244TH AVENUE, WOOD VILLAGE, OREGON

DRAWN BY: JAB
CHECKED: JMc
DATE: APRIL 2021
PROJECT NUMBER: 23514.174
SHEET DRAWING NO: HA2
SHEET 2 OF 3

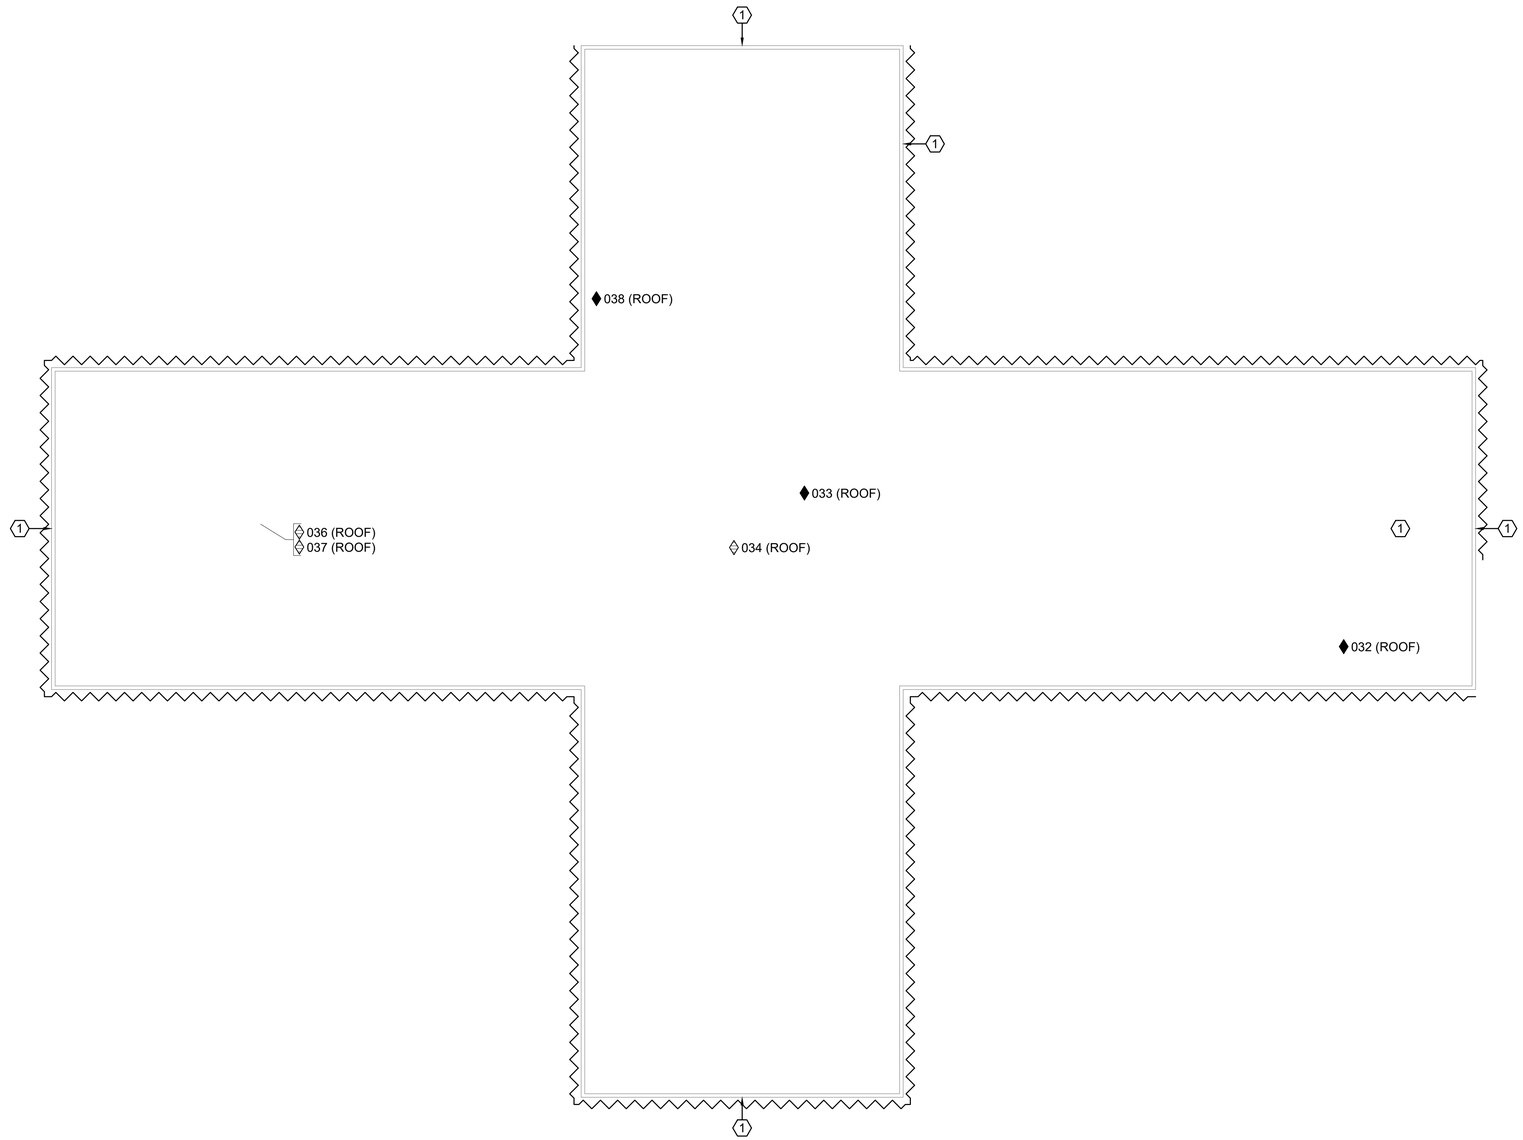
(1) DOOR WITH ASBESTOS-CONTAINING CAULK TO BE REMOVED.

WINDOWS WITH ASBESTOS-CONTAINING CAULK TO BE REMOVED

DRAWING REFERENCE	FIELD CODE	LAB RESULT	MATERIAL SAMPLED
◆032	23514.174-0032	(-/-/-/-/-/-/+/+/+)	BUILT-UP ROOFING
◆033	23514.174-0033	(-/-/-/-/-/+/+/-/-/+)	BUILT-UP ROOFING
◇034	23514.174-0034	(-)	
◇036	23514.174-0036	(-/-/-/-/-/-/-/-)	BUILT-UP ROOFING
◇037	23514.174-0037	(-)	MASTIC
◆038	23514.174-0038	(+)	MASTIC

1. ASBESTOS-CONTAINING BUILT-UP ROOFING, MASTIC, AND SHEATHING TO BE REMOVED FROM THROUGHOUT BUILDING.
2. ASBESTOS-CONTAINING ROOFING DEBRIS GENERATED DURING ROOFING REMOVAL TO BE CONTAINED AND REMOVED.
3. APPROXIMATELY 35 LEAD-CONTAINING VENT PIPE CAPS TO BE REMOVED.
